FlexiScope 2 and 3 probes for visual inspections.
 Fitting product: inspection system FlexiVision 100 with FlexiScope 3 camera handpiece.

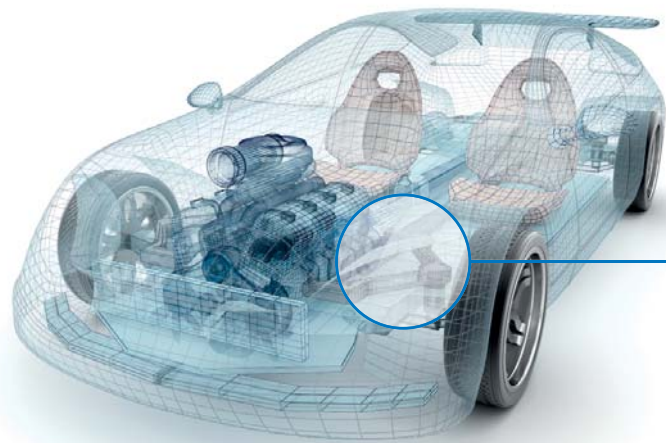
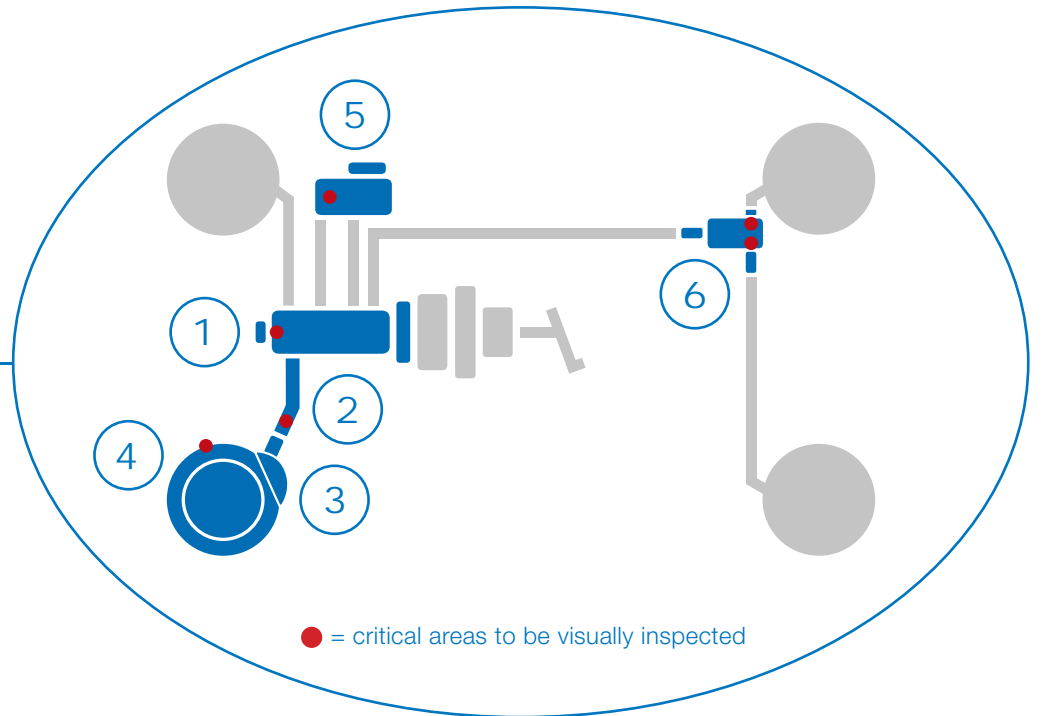
① Master cylinder

Inspection area	Defect	Probe
	Central bore holes bore holes	Chip residues Burrs Porosities	 ø 2.7 - 4.0 mm direction of view: 0° / 70°

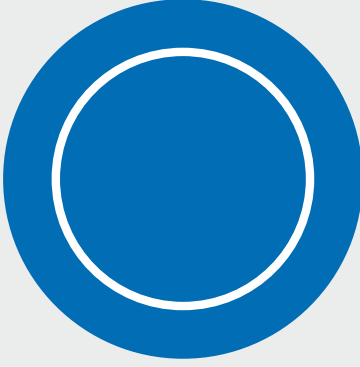
④ Brake disk			
	Inspection area	Defect	Probe

Ventilation slots	<div style="border: 1px solid black; padding: 5px;"> Sand residues Cracks Casting defects </div>

ø 1.0 mm, ø 1.8 mm, ø 2.0 mm direction of view: 0°
⑤ Brake fluid reservoir			
	Inspection area	Defect	Probe

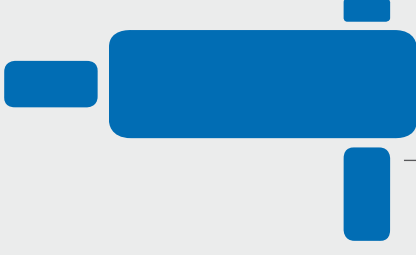
ø 4.0 mm direction of view: 0°
⑥ Compensator			
	Inspection area	Defect	Probe

Central bore hole Bore holes	<div style="border: 1px solid black; padding: 5px;"> Chip residues Burrs Porosities </div>

ø 2.0 mm, ø 2.7 mm direction of view: 0° / 70°
